Manhole Inspection Summary

Manhole # S19C__015MH

Insp Date: **10/15/07 9:39 AM**

Location Address: **500 PULASKI ST**

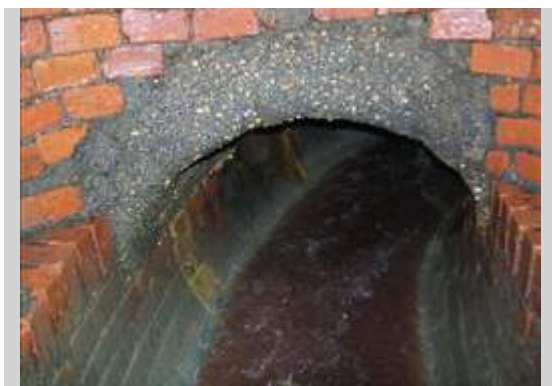
12 O'Clock Outflow

27 in. Circular Gravity Sewer
Pipe Out @ 12 O'Clock

Pipe Height: **27.6** (in.) Rod and Bar (Angled)
Pipe Material: **Clay** ☐ Pipe Lined
Invert Depth: **13.50** (ft.) Flow Characteristics: **Slow**
Deposits: ☒ None ☐ Mud ☐ Sludge ☐ Debris ☐ Grease
Silt Depth: (in.) Deposits Extent:
Infiltration: **None** Pipe Seal Cond: **Sound**

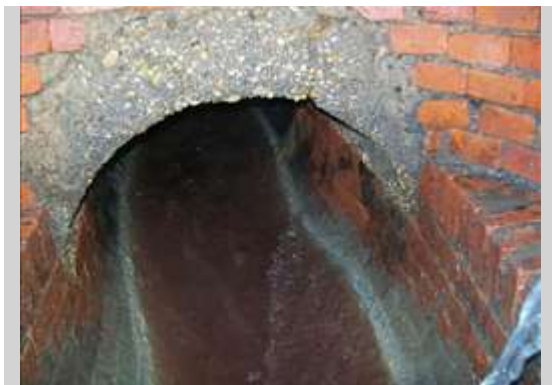
6 O'Clock Inflow

27 in. Circular Gravity Sewer
Pipe In @ 6 O'Clock

Pipe Height: **27.6** (in.) Rod and Bar (Angled)
Pipe Material: **Clay** ☐ Pipe Lined
Invert Depth: **13.39** (ft.) Flow Characteristics: **Slow**
Deposits: ☒ None ☐ Mud ☐ Sludge ☐ Debris ☐ Grease
Silt Depth: (in.) Deposits Extent:
Infiltration: **None** Pipe Seal Cond: **Sound**
